Appendix 10.4

Energy Isles Wind Farm, Shetland Islands

Peat Landslide Hazard and Risk Assessment

April 2019

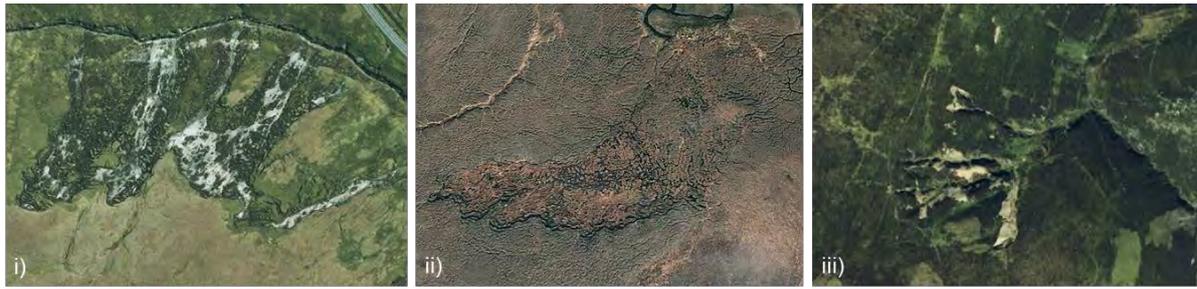
Plate 1 Characteristics landslide types in UK uplands: i) multiple peat slides with displaced slabs and exposed substrate, ii) retrogressive bog burst with peat retained within the failed area, iii) multiple peaty soil slides in a headwater area with displacement of thin soils exposing substrate (all images are at a similar scale and approximately 400m in width)

3.2.3 For the purposes of this assessment, landslide classification is simplified and split into three main types, typical examples of which are shown in Plate 1. Dimensions, slope angles and peat depths are drawn from charts presented in Evans and Warburton (2007). The term “peat slide” is used to refer to large-scale (typically less than 10,000 of cubic metres) landslides in which failure initiates as large rafts of material which subsequently break down into smaller blocks and slurry. Peat slides occur ‘top-down’ from the point of initiation on a slope in thinner peats (between 0.5 and 1.5m) and on moderate slope angles (typically 5-15°).

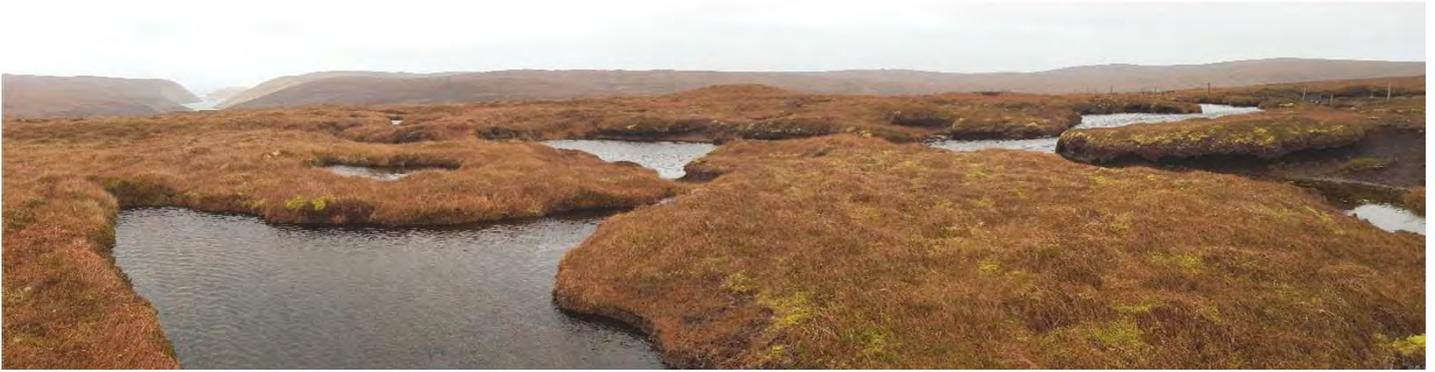
Photo 1 Summit pool complex on Tonga Field, pools are generally shallow with visible bottoms

- 2.5.3 The highest elevations are characterised by summit mires with extensive pool complexes. Pools range in size from small features >1.0m across to extensive water bodies (up to 90m long and 50m wide; e.g. Photo 1). The majority of pools larger than 10m² in area have been mapped and are shown on Figure 6. Most of the pools observed on site were shallow, with bare peat visible under the water surface (Photo 2), often showing evidence of desiccation cracking from drier periods. There was some indication of slow downslope creep of pools, with bulging on the downslope sides (Photo 3) and in some areas, sequences of interconnected former pools that had been drained following collapse of the sidewall of the lowest pool (Photo 4).

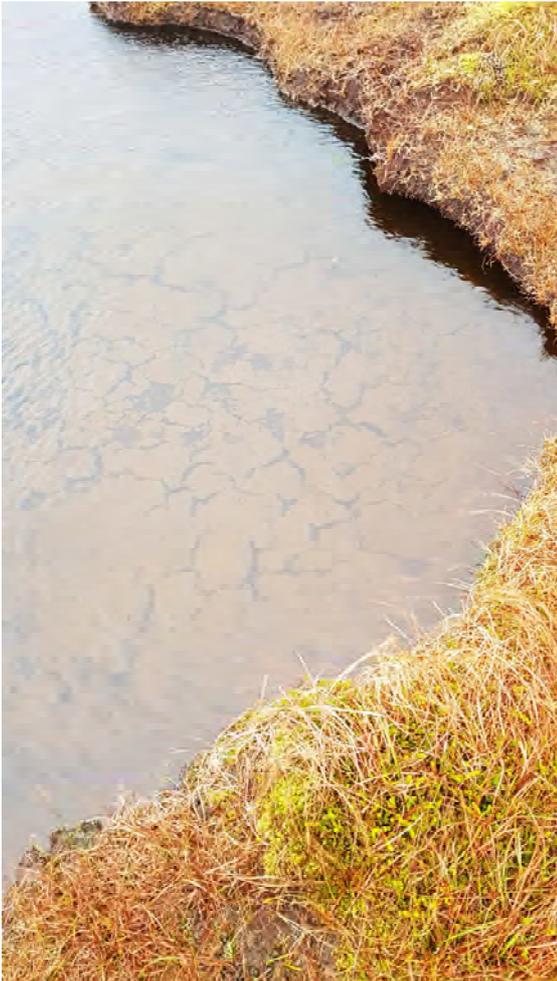
Photo 2 Desiccation cracking at the base of a pool (caused by irreversible drying during dry periods)

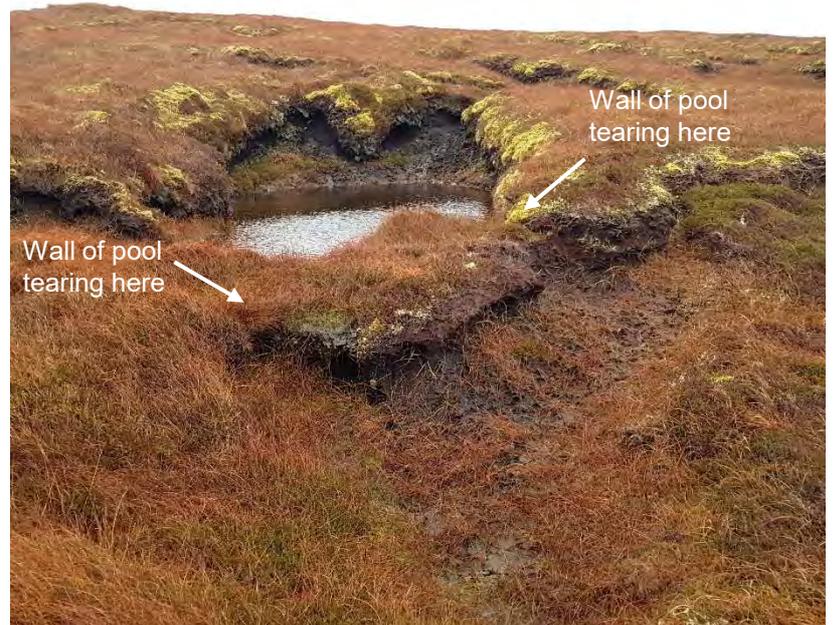
Photo 3 Failing front face of bog pool

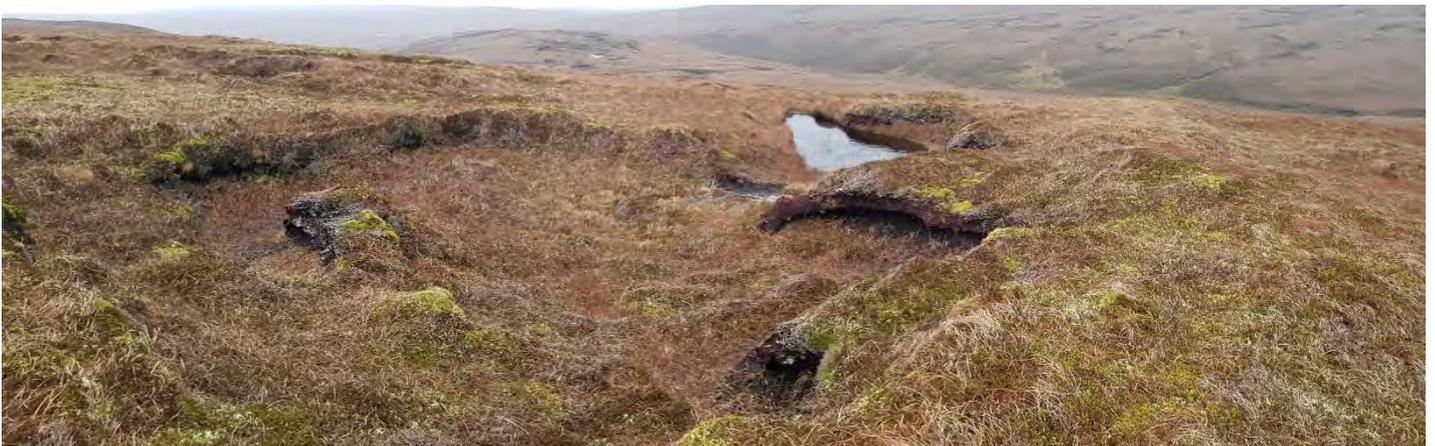
Photo 4 Upper (former) pool drained into lower pool

- West flank of Muckle Bratt-houll above unnamed tributary to Gloup Voe (minor cracking and localised evidence of pipes)
- 2.5.8 Areas of bare ground (with exposed mineral substrate) were observed in some gully floors and on some summits, usually in areas of pools and are interpreted to be the dried out footprints of former pool systems (Photo 4).

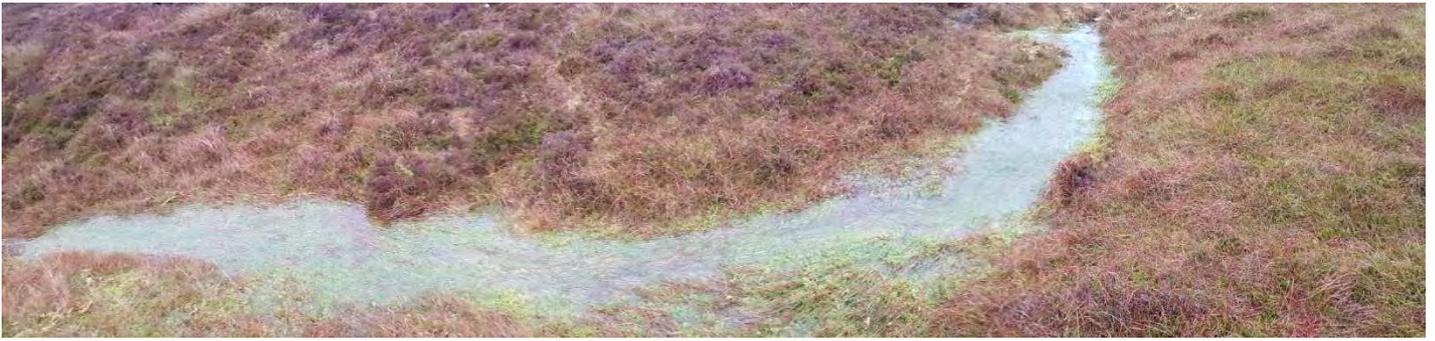
Photo 5 Sinuous diffuse surface drainage pathway (largely sphagnum below water surface)

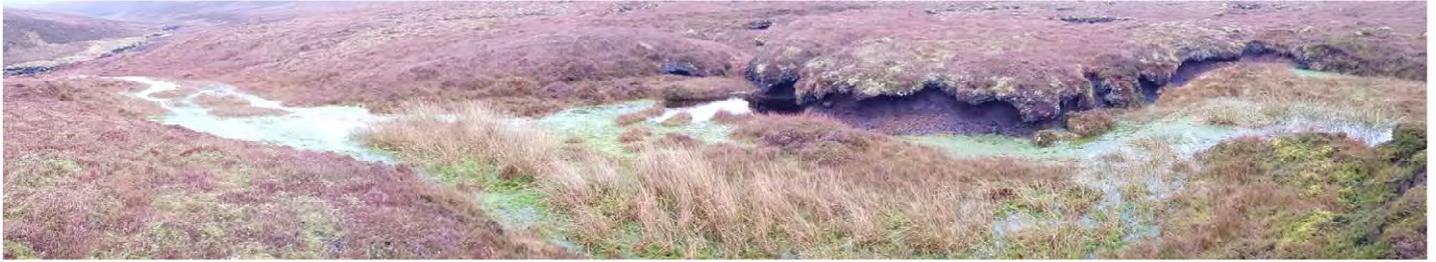
Photo 6 Sphagnum and Juncus (reeds) in diffuse surface drainage pathway

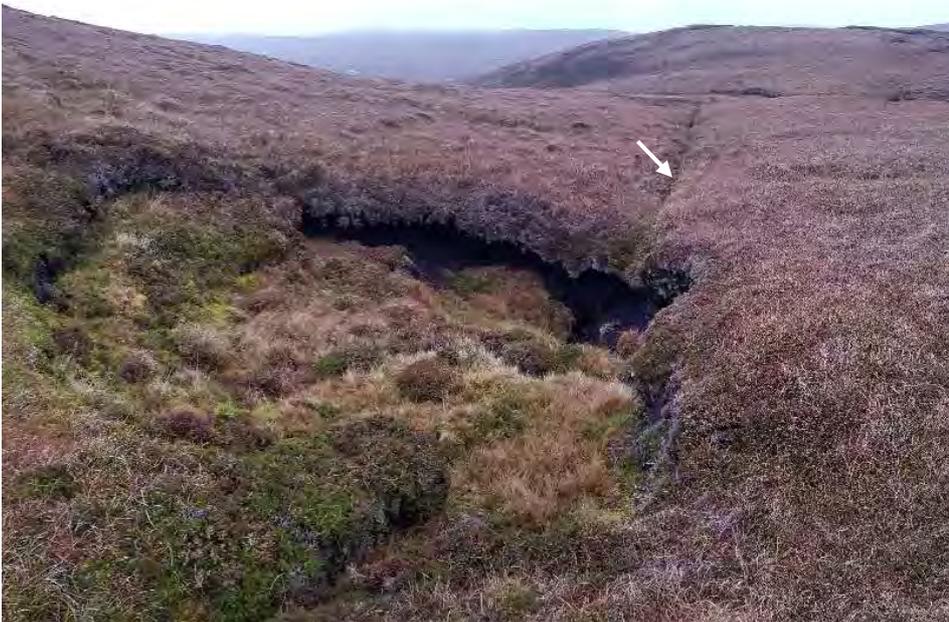
Photo 7 Large collapsed pipe within alignment of moor drain (grip, arrowed)

- North-east flank of Hill of Vigon above the North Burn of Vigon (tension cracks, tearing and pool collapses, also a number of collapsed pipes, e.g. Photo 7)

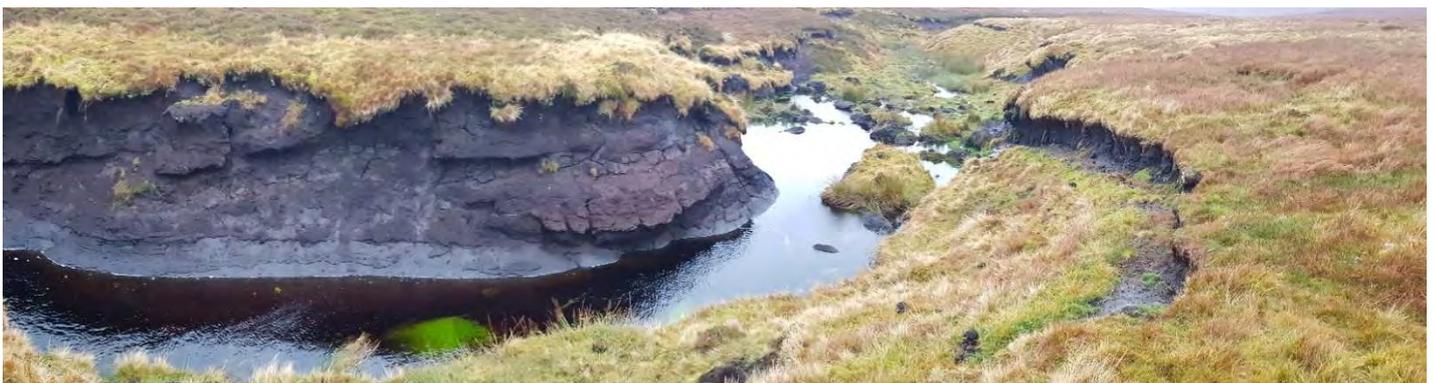
Photo 8 Significant under-cutting of streamside peat deposits by fluvial erosion (on Burn of Kedillsmires)

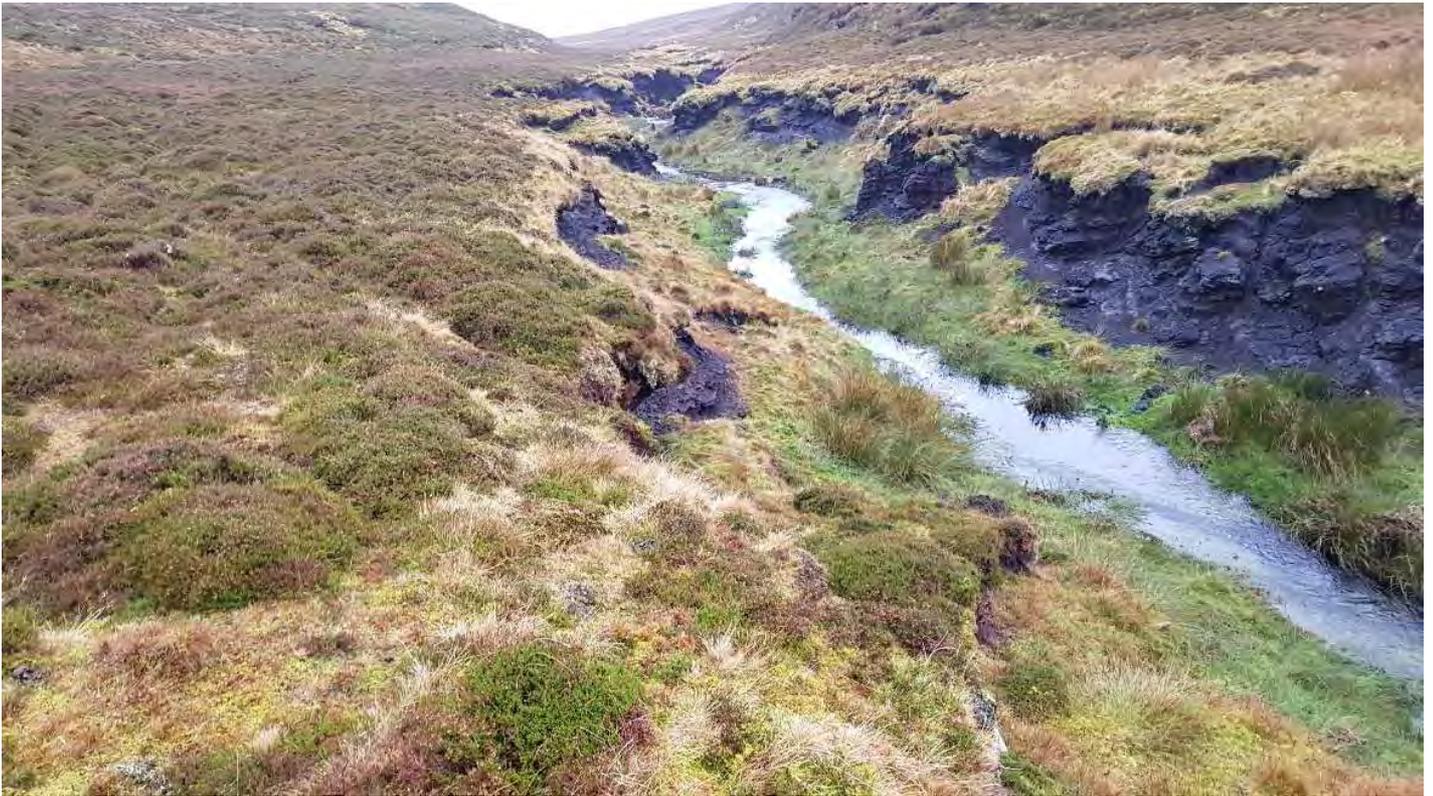
Photo 9 Eroding peat caused by fluvial incision (below Little Bratt-houll)

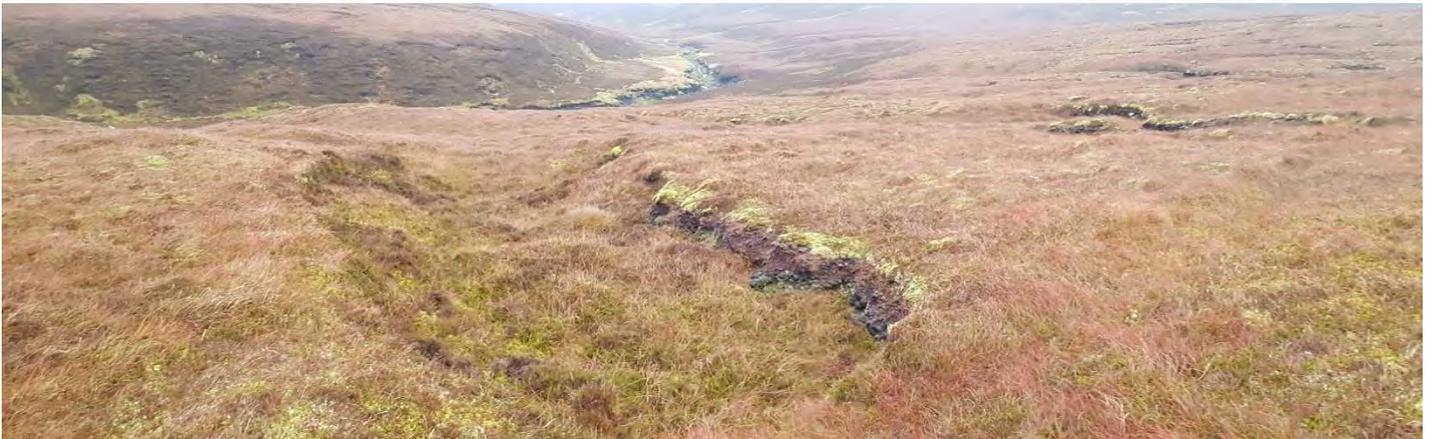
Photo 10 Minor crescentic scarp, possibly old gully head (below Muckle Bratt-houll)

- 2.5.7 The majority of 'instability' features appear to relate to small-scale downslope creep of peat deposits on moderate slopes. In these areas, small crescentic headscarps (Photo 10) and tension cracks are visible (typically a few metres in dimension, Photo 11), but there is generally little evidence of downslope deposits such as blocks, rafts or slurry. These forms of instability are focused in the following areas:

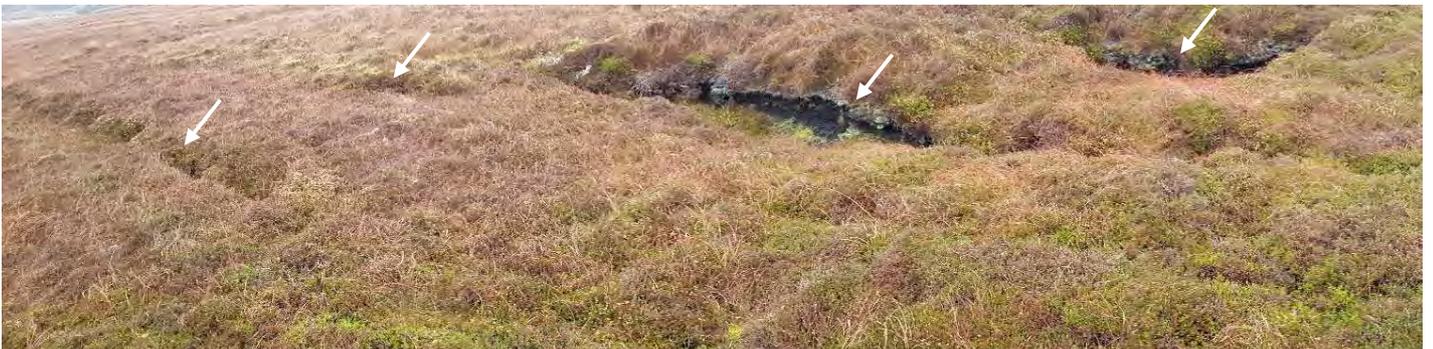
Photo 11 Tiers of tension on cracks (arrowed) associated with minor creep / ground displacement
